PRODUCT CORRECTION

Air10™ Series Humidifier Software Upgrade

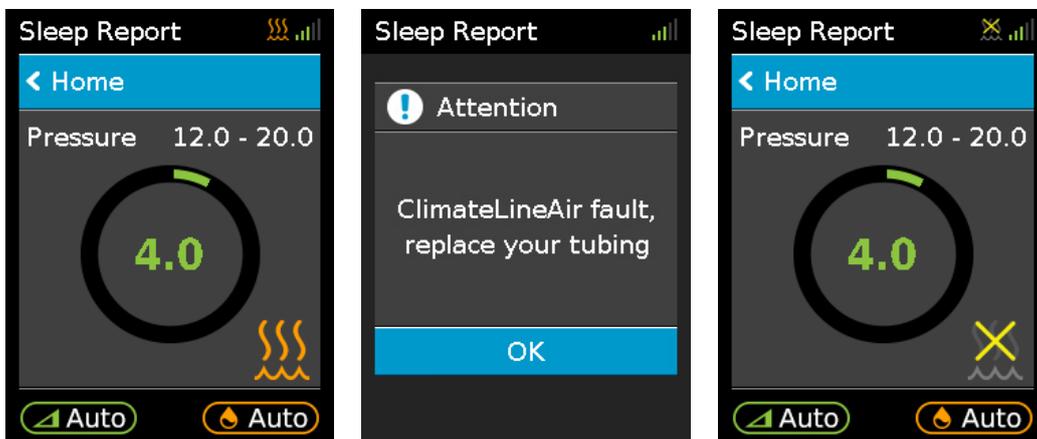
A number of Air10 devices have shown a ClimateLineAir™ error message on the user interface. This is primarily caused by the software interpreting static electricity as a fault with the tubing. Static can be common in cold and dry environments. When this condition occurs, the software generates the message and turns the humidifier off. This is indicated by a yellow “X” through the humidification symbol on the screen as shown below.

Normal operation; error message displayed; device showing humidifier off

Air10 devices affected by this issue are safe to use and there is no disruption to positive air pressure therapy. Today, the message is cleared by pressing OK. Humidification can be resumed by power cycling the device, or by disconnecting and reconnecting the ClimateLineAir tube. With the software upgrade, static electricity will no longer be incorrectly interpreted as a ClimateLineAir fault.

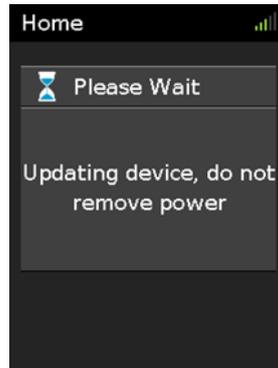
Once the software download is complete, it is ready to be installed. The device will display the message "Updating device, do not remove power." This message will flash on the screen until the upgrade is completed (approximately 30 seconds) and then disappear. When the device has completed installing the software, it will automatically reboot with the new software. This will be a seamless upgrade process for your patients.

The software will install when the device is in standby mode with no disruption of therapy to the patient.

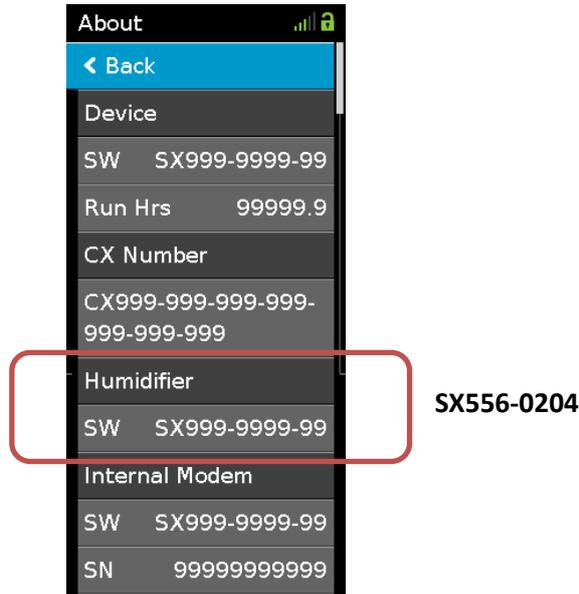
HMEs can view the software versions on the device by selecting the "Settings" menu when in clinical mode. Patients can view the software versions on the device by selecting "My Options." Please note that this will only be visible to patients when "Essentials" is set to "Plus." The software versions are listed under the "About" option.

The enhanced humidifier software version is **SX556-0204**.
